Motorcycle Service Bulletin – SBMCAP1501

SUBJECT: NBC110 Steering Stem Inspection

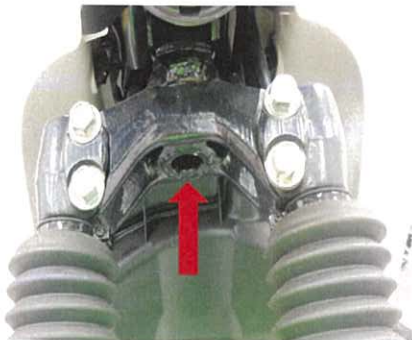
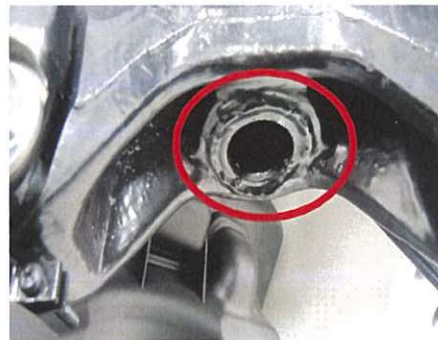
It has come to our attention that an issue may arise concerning the integrity of the weld on the base of the steering stem on the NBC110 Australia Post units. At present this is an isolated case whereby the forks were able to drop away from the steering stem.

The following photos show the area of concern.

In the interest of rider safety it is advised that the front forks are checked for movement and the welded area, shown below, is visually checked for damage or cracking as part of the pre ride inspection.

If movement of the forks or cracking of the weld is detected the unit should not be ridden and the appropriate personnel are advised to organise the repair.
